# FERRIC CHLORIDE WATER TREATMENT FACILITY 2017 ANNUAL REPORT

NPDES/SDS PERMIT No: MN0067377

PRIOR LAKE - SPRING LAKE  
WATERSHED DISTRICT

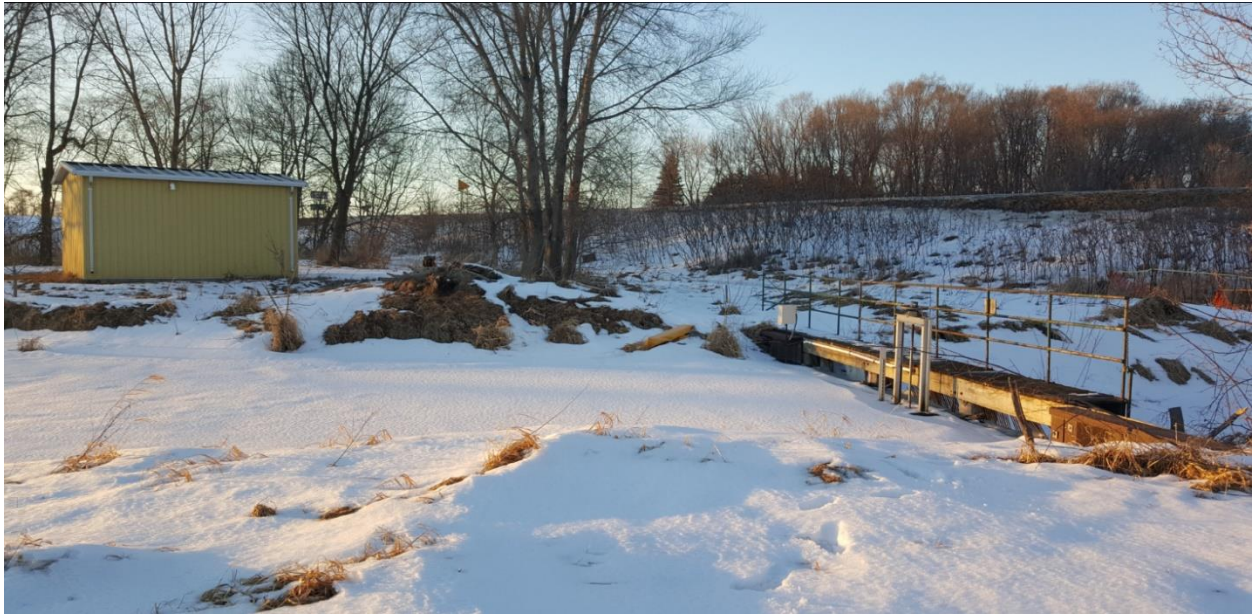
FIGURE 1 FERRIC CHLORIDE SHED AND WEIR

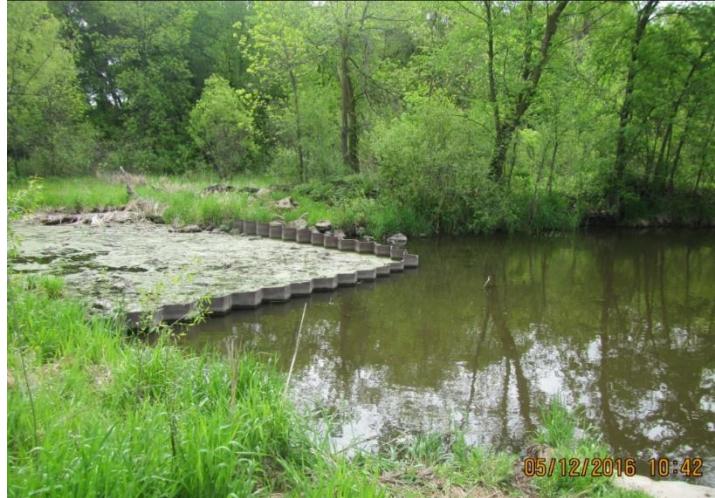
FIGURE 3 BYPASS WEIR AT DESILT POND

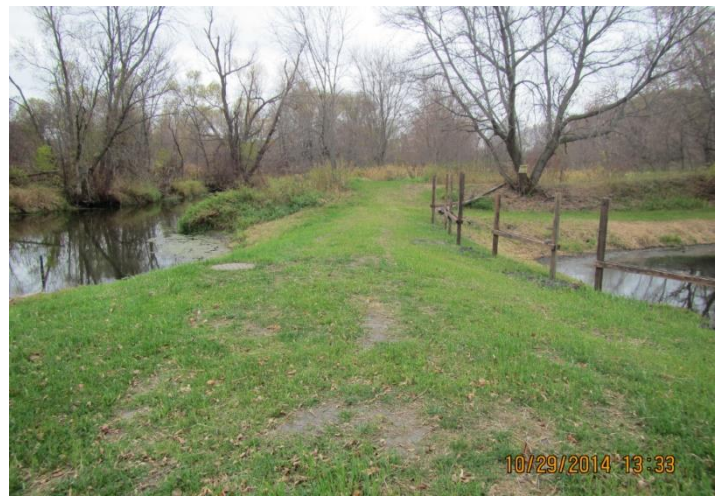
The treatment system involves the injection of 32.5% liquid  $\text{FeCl}_3$  solution into a stormwater pond, or desiltation basin. The iron within the  $\text{FeCl}_3$  binds with the dissolved phosphorus in the water and creates colloidal particles (floc) which settle at the bottom of the basin. The treated water then flows downstream into Spring Lake.

FIGURE 2 BERM AND INJECTION POINT AT DESILT POND

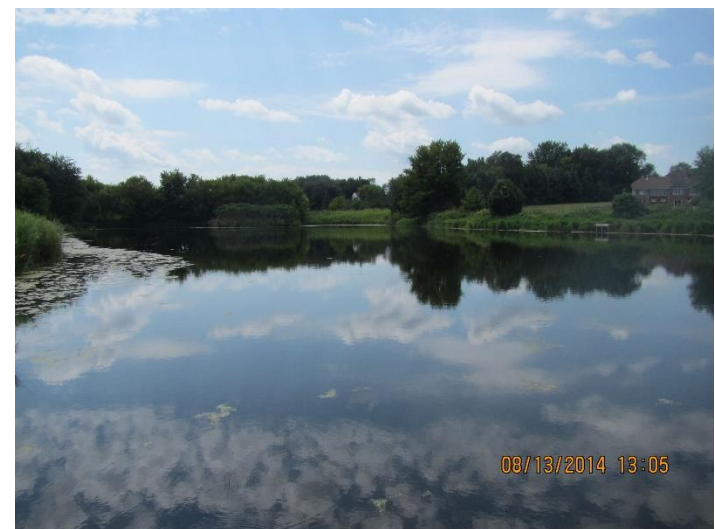
FIGURE 4 DESILT POND, STANDING AT OUTLET

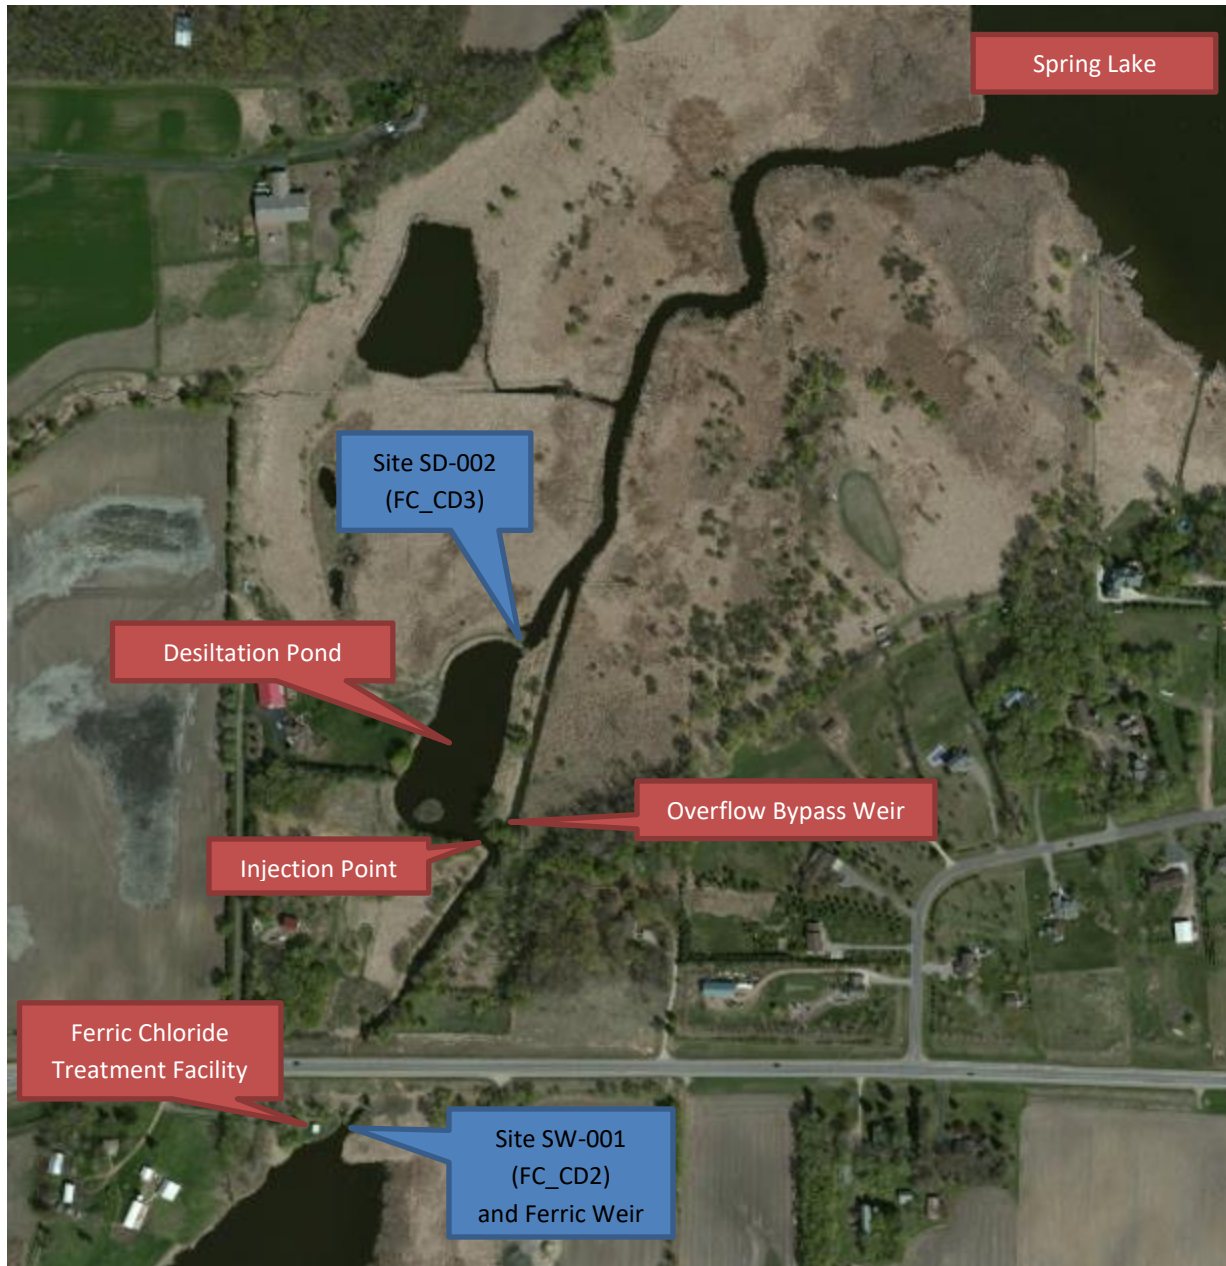
FIGURE 5 AERIAL MAP OF FERRIC CHLORIDE TREATMENT SYSTEM

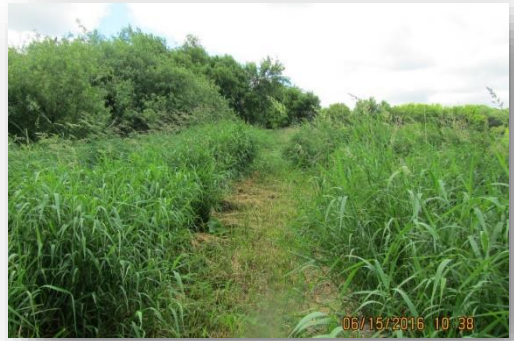
Access is needed to the Desilt pond outlet and injection site. A grass path to the outlet of the Desilt pond was regularly mowed by the homeowner, Gary Stevens. When the water level of the outlet was low enough, he voluntarily drove his lawnmower across the outlet and mowed a path from the outlet of the Desilt pond to the injection site at the berm. When water conditions were too high, staff weed whipped a path to the injection site.

**FIGURE 6 WEED WHIPPED PATH FROM DESILT POND OUTLET TO INJECTION SITE**

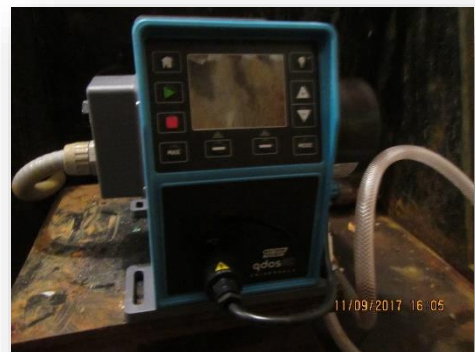
City staff is also called upon when there are issues with the pump or lines during the operating season. On July 25, the pump indicated a leak was detected and the pump was shut off automatically. The pump was restarted, but failed again shortly thereafter. The city repaired the pump on August 2<sup>nd</sup>, but after the repair, it was discovered that the pump was dosing almost twice as much (2 gallons per hour) as it was programmed to pump, from August 3 to October 6. This caused no harm and did not exceed permit regulations; it was just excess usage. The City of Prior Lake staff and the pump manufacturer inspected the pump and determined there was something wrong with the computer board and the pump needed to be replaced.

**FIGURE 7 NEW FERRIC CHLORIDE PUMP**

Installation of the new pump (Figure 7) occurred on October 30, but was unable to be started because the power had to be disconnected due to some road maintenance from October 23 to November 9. The new pump resumed pumping on November 15. After verification that the new pump was working, it was shut off for the winter on November 30. The City of Prior Lake winterized the pump and system on December 1. All the work from the City was done at no charge to the District.

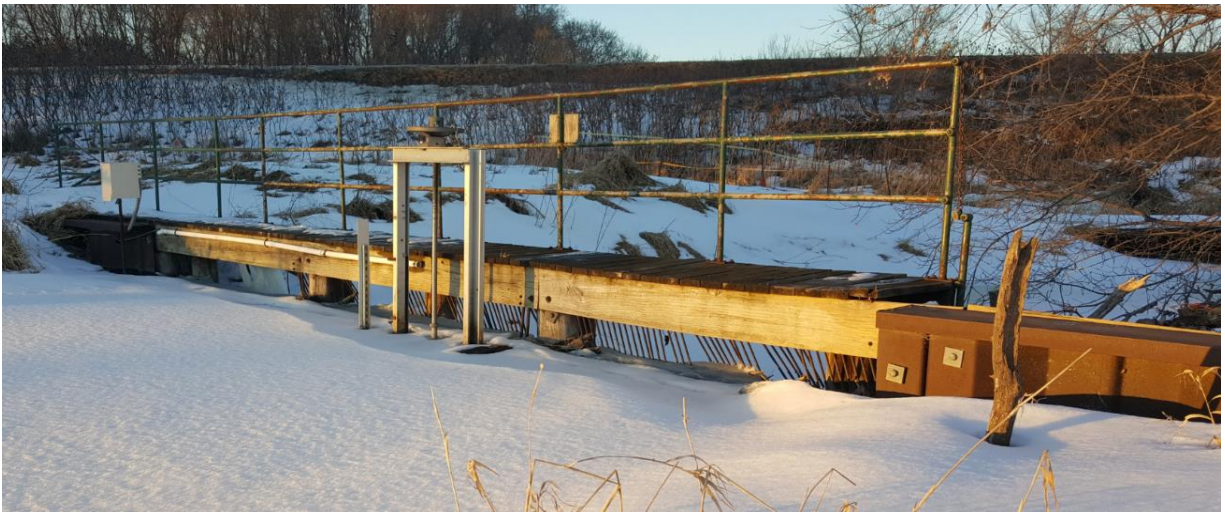
Carp have been observed in the wetland adjacent to the Ferric Chloride shed (Highway 13 Wetland) and the water has become noticeably more turbid in the past few years (visually and in data). The turbid water could be a sign of carp infestation. Because the current fish barrier is missing tines and inoperable, an engineer at WSB consulting designed a new concept for the fish barrier in 2017. Another option includes an electric barrier immediately downstream of the weir. A carp population estimate should also be conducted. These options will be further evaluated in 2018 and if funding is available, construction may take place.

The Ferric Chloride weir is also showing signs of age. Repair is anticipated to take place in 2018 to address the cracks, loose boards, and unstable railings.

**FIGURE 9 FERRIC CHLORIDE WEIR AND FISH BARRIER**

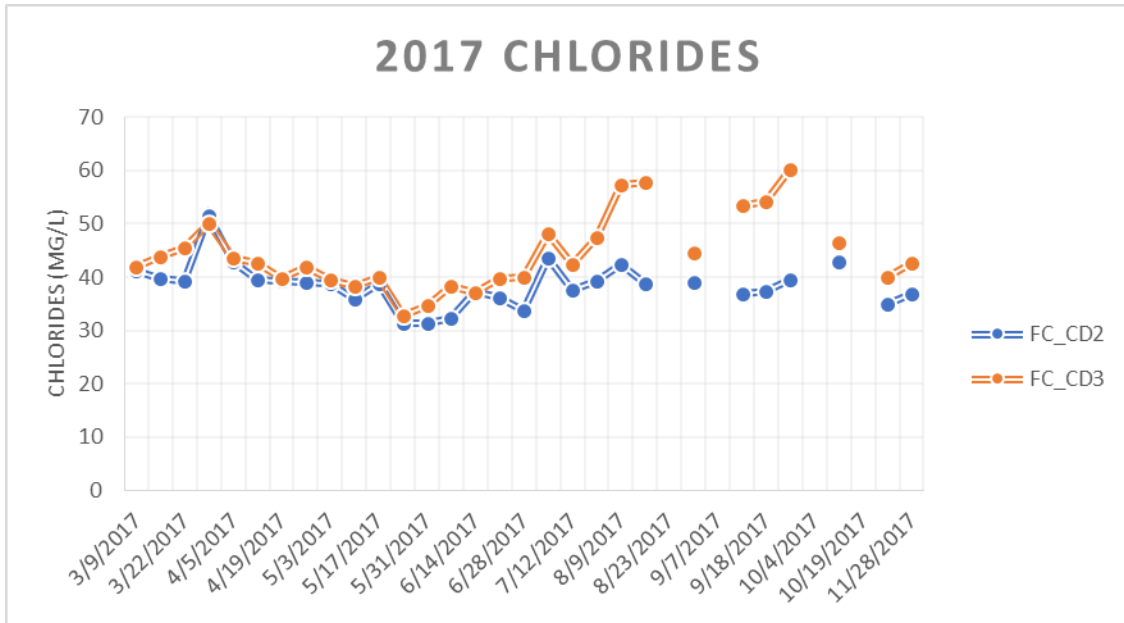
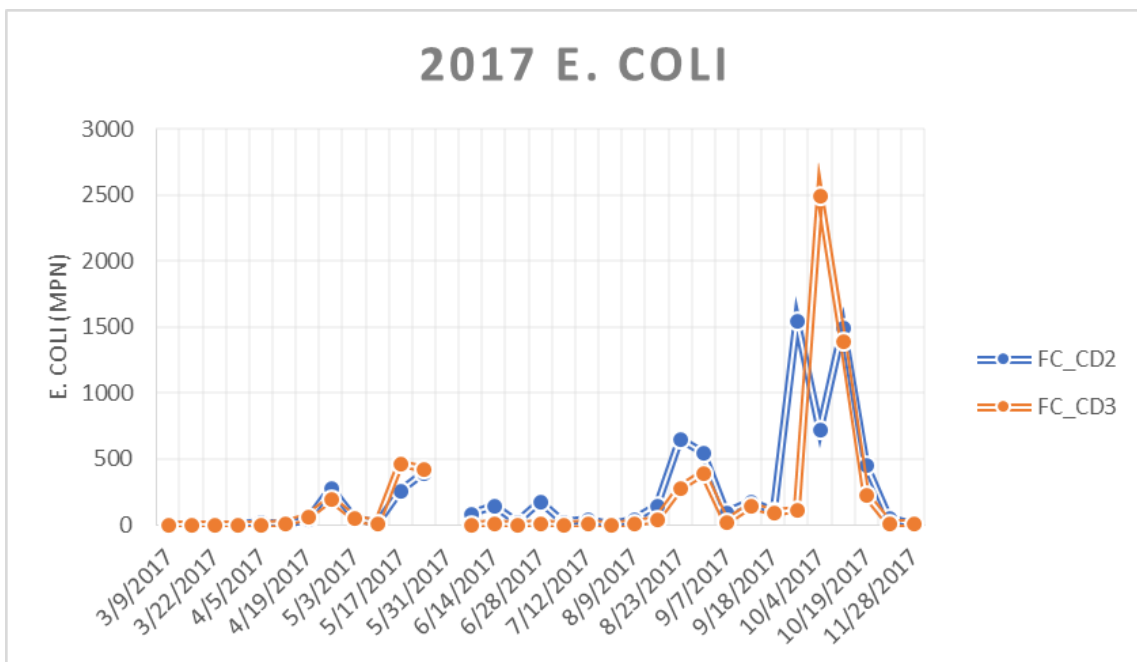
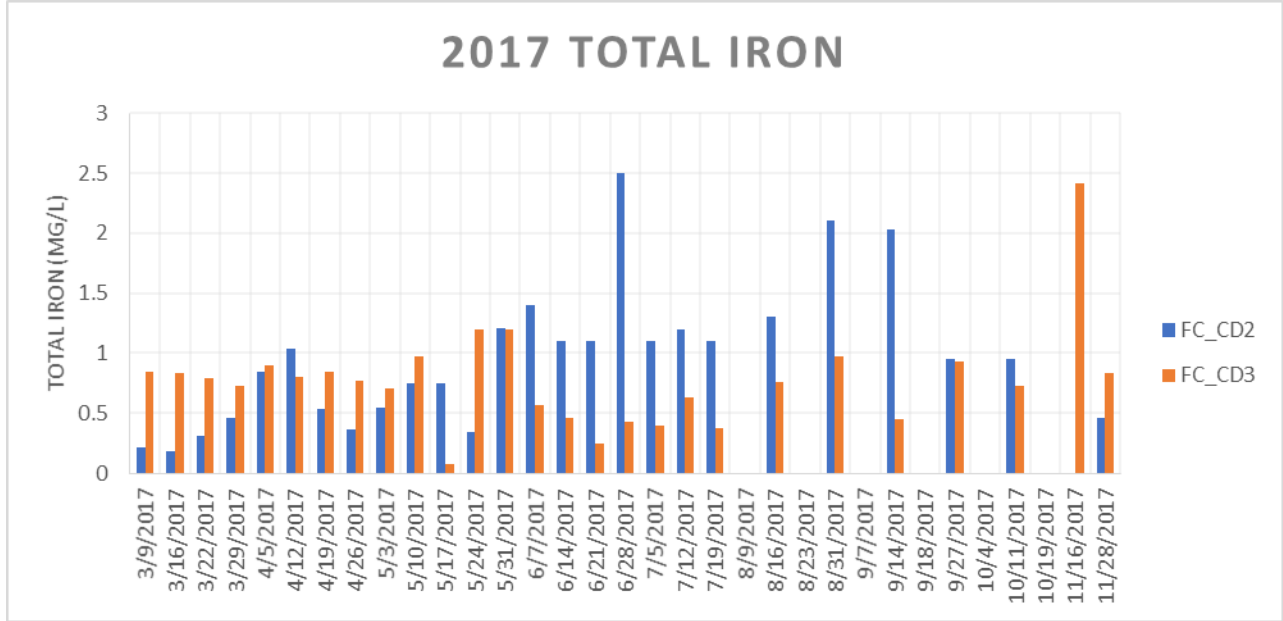
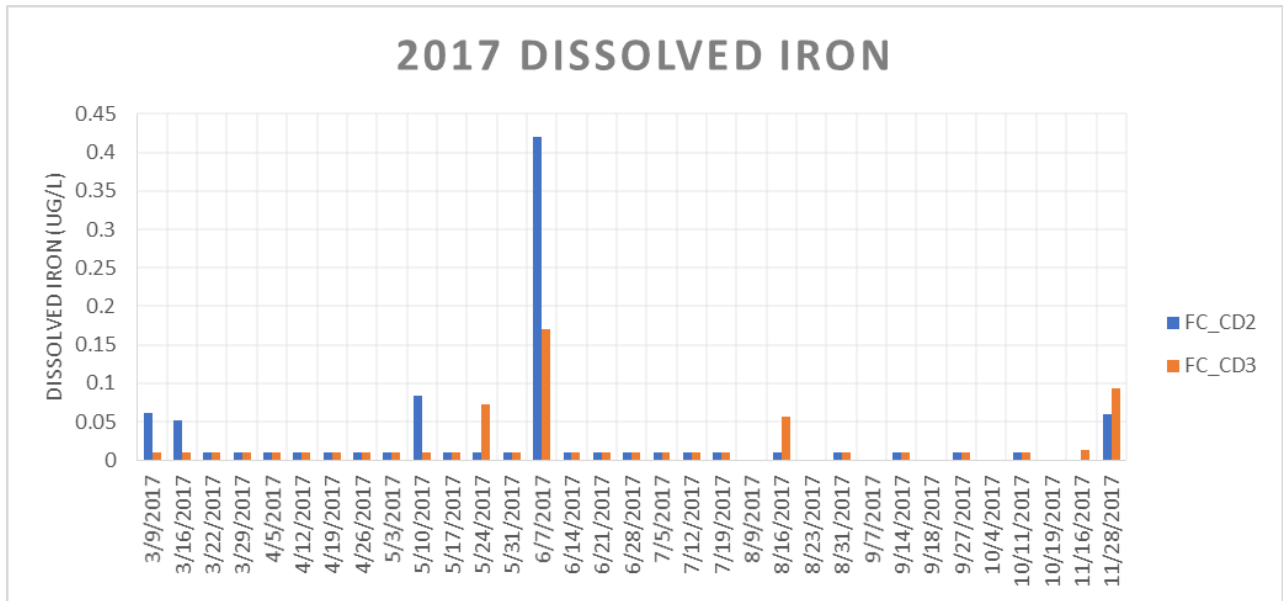
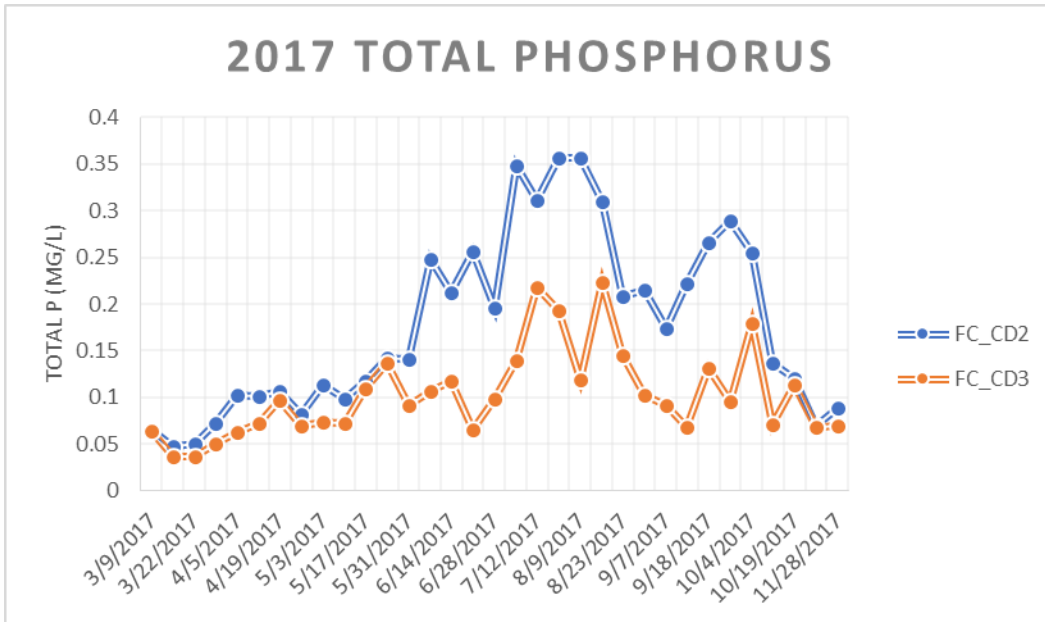
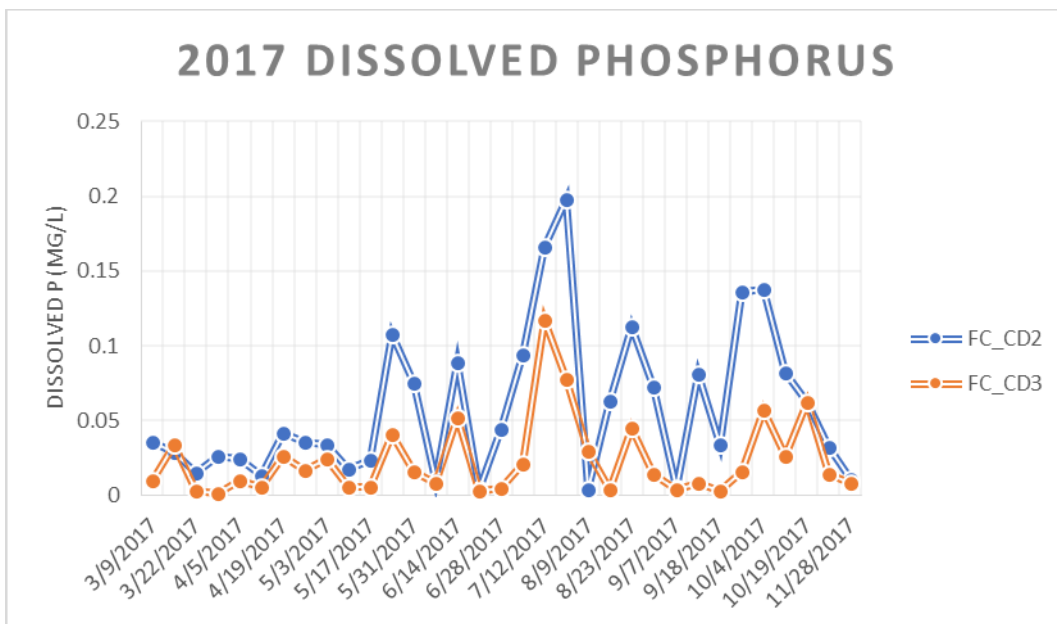
The following graphs display the monthly mean of samples taken in 2017, before treatment at site SW-001 (FC\_CD2) and after treatment, at SD-002 (FC\_CD3). Treatment began on March 5 and ceased on November 30. During that time, samples were taken once per week. Samples taken on July 25, August 2, and October 25 were not receiving treatment at the time of the sample and were therefore not included in the graphs below.
