Ferric Chloride Water Treatment Facility 2019 Annual Report

NPDES/SDS Permit No: MN0067377

PLSLWD Ferric Chloride Water Treatment Facility (NPDES/SDS Permit No. MN0067377)
2019 Annual Report

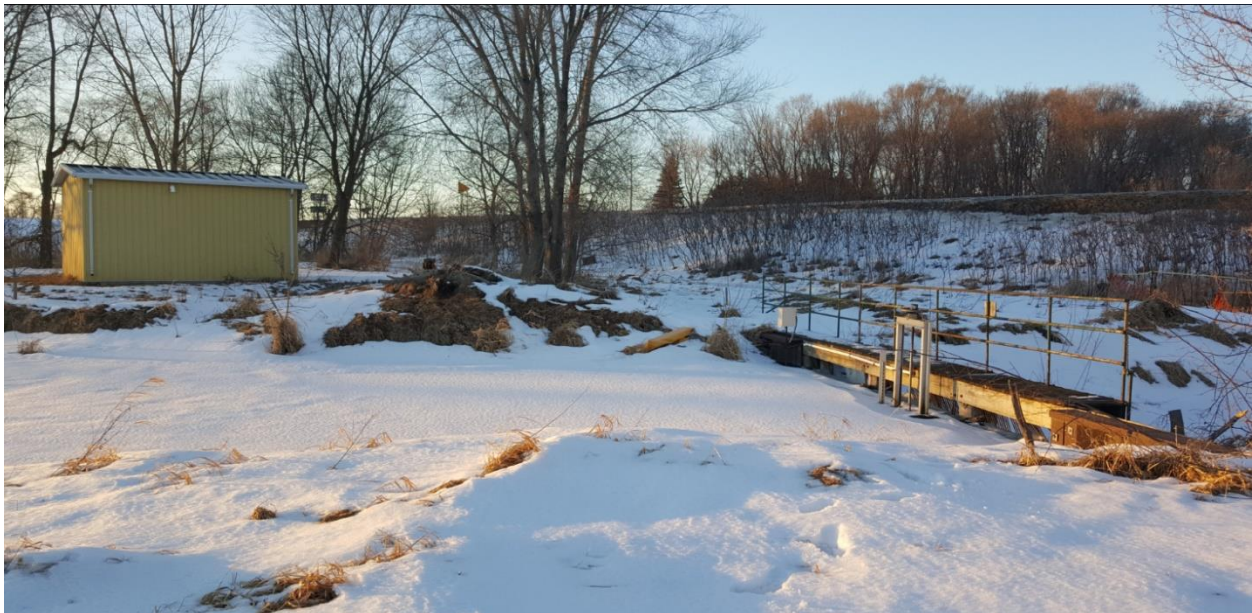
Figure 1. Ferric Chloride Shed and Weir

In 1998, the PLSLWD constructed the ferric chloride (FeCl_3) treatment system to precipitate SRP out of stormwater from County Ditch 13, the main inflow to Spring Lake. The system was constructed as part of a Minnesota Pollution Control Agency (MPCA) Clean Water Partnership Implementation Project. The treatment system began operating under a permit from the Department of Natural Resources. In 2004, the treatment system permit was renewed as a National Pollutant Discharge Elimination System permit administered by the MPCA. The District applied to the MPCA for a renewed permit in 2009. That permit was approved in 2012. However, the system did not operate in 2011 or 2012 because it no longer met the requirements of the permit. During this time, the District was working toward a design that would meet requirements of the new MPCA permit. The old system injected FeCl_3 directly into the channel immediately downstream of the Ferric Chloride weir on the south side of Highway 13 where it would mix until reaching the desiltation pond.

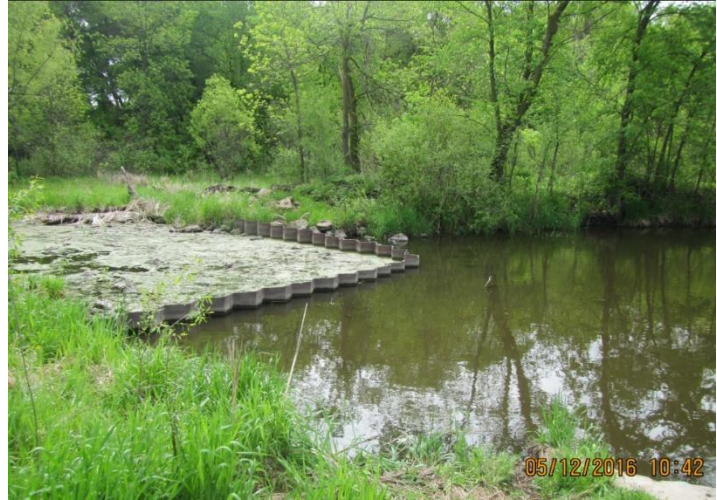
Figure 2. Bypass Weir

In July 2013, the treatment facility began operating again after it was retrofitted to meet new MPCA permit requirements. The new design transfers FeCl_3 underground for 900 feet from the treatment building through a double walled pipe to a culvert north of Highway 13 that flows directly into the desiltation basin. The new design addresses the previous concerns of the MPCA by avoiding direct discharge into a water of the state, and instead, goes directly into a stormwater pond.

The retrofit project was designed by consultants Bolton and Menk, Inc. and installed by S.M. Hentges & Sons, Inc. The new design allowed for more water to be treated as compared to the old system. With the old system, high flows could resuspend phosphorus-iron flocculants within the basin and flush the flocculent downstream and into Spring Lake. The new system was designed to overtop a bypass weir (and flow around the desiltation basin) before the flows reached a point of resuspension in the pond. This allows for the maximum amount of phosphorus to be treated without resuspending the material in the desiltation basin. Staff reviewed the project design and confirmed it was operating as designed.

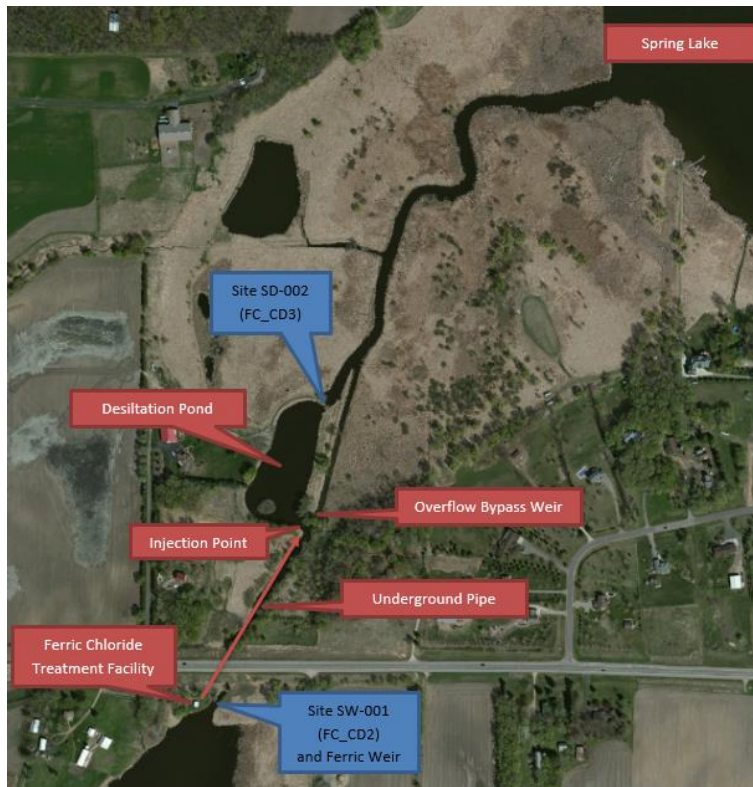
Figure 3. Aerial Map of Ferric Chloride Treatment System

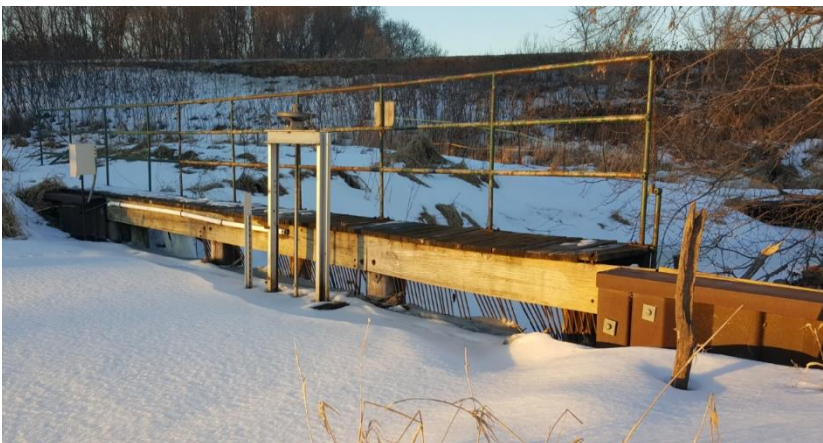
Figure 6. Ferric Chloride Weir and Fish Barrier

Carp have been observed in the wetland adjacent to the Ferric Chloride shed (Highway 13 Wetland) and the water has become noticeably more turbid in the past few years (visually and in the data). The turbid water could be a sign of carp infestation which could have been caused by missing tines in the fish barrier on the weir. In 2018, WSB Consulting estimated 1,452±615 carp are living in the pond, equating to a biomass of 198±61 pounds per acre. Because the current fish barrier is missing tines and inoperable, an engineer at WSB Consulting designed a new concept for the fish barrier. This will be constructed in 2020.

The Ferric Chloride weir is also showing signs of age. Repair is anticipated to take place at the same time as the fish barrier is constructed and will address the cracks, loose boards, and unstable railings.

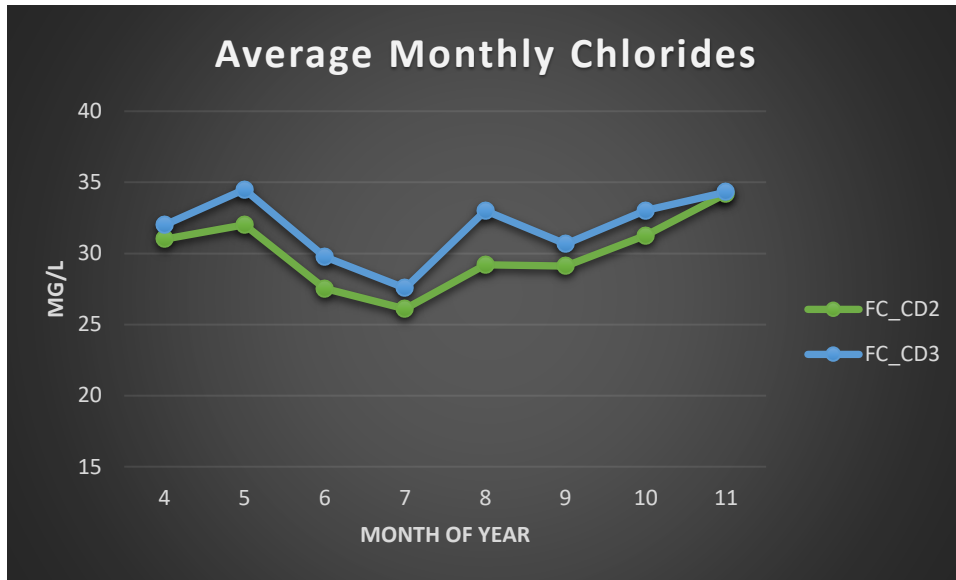
Figure 6 Chloride from de-icing salt, water softening, dust suppressant, fertilizer, and manure gets into lakes and streams. The state water quality standard for chlorides is 230 mg/l, which these sites are well below.

The following graphs display the monthly mean of samples analyzed in 2019, before treatment at site SW-001 (FC_CD2) and after treatment, at SD-002 (FC_CD3). These are required to be reported by the permit. Treatment began on April 1 and treated continuously until November 12. During that time, water quality sampling and monitoring was conducted once per week.

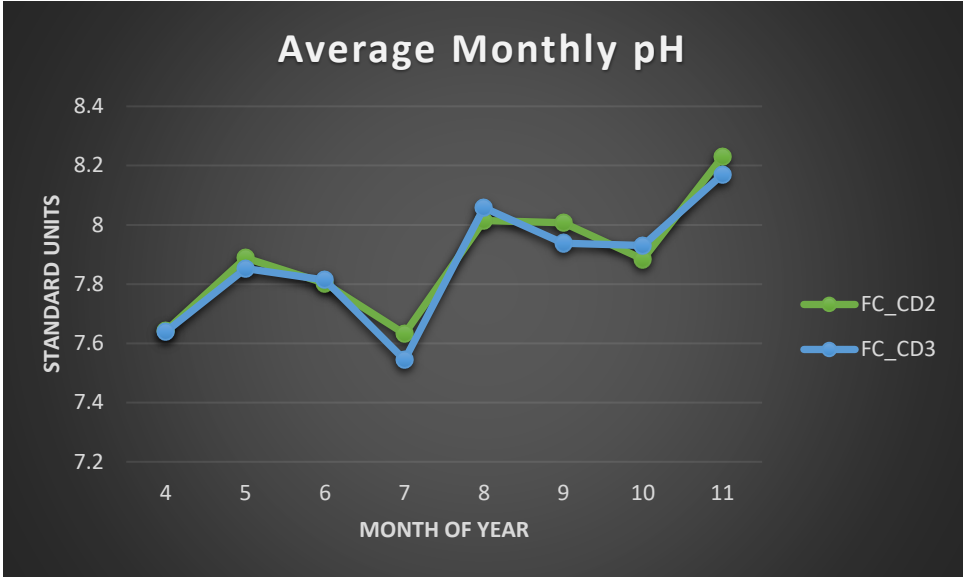
Figure 16 The pH water quality standard is a minimum of 6.5 and max of 8.5.
