FERRIC CHLORIDE WATER TREATMENT FACILITY 2018 ANNUAL REPORT

NPDES/SDS PERMIT No: MN0067377

January 2019

PRIOR LAKE - SPRING LAKE
WATERSHED DISTRICT

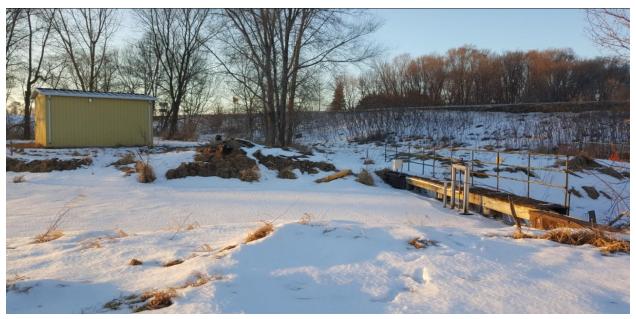
FIGURE 1 FERRIC CHLORIDE SHED AND WEIR

The treatment system involves the injection of 32.5% liquid FeCl₃ solution into a stormwater pond, or desiltation basin. The iron within the FeCl₃ binds with the dissolved phosphorus in the water and creates colloidal particles (floc) which settle at the bottom of the basin. The treated water then flows downstream into Spring Lake.

In 1998, the PLSLWD constructed the ferric chloride (FeCl₃) treatment system to precipitate SRP out of stormwater from County Ditch 13, the main inflow to Spring Lake. The system was constructed as part of a Minnesota Pollution Control Agency (MPCA) Clean Water Partnership Implementation Project. The treatment system began operating under a permit from the Department of Natural Resources. In 2004, the treatment system permit was renewed as a National Pollutant Discharge Elimination System permit administered by the MPCA. The District applied to the MPCA for a renewed permit in 2009. That permit was approved in 2012. However, the system did not operate in 2011 or 2012 because it no longer met the requirements of the permit. During this time, the District was working toward a design that would meet requirements of the new MPCA permit. The old system injected FeCl₃ directly into the channel immediately downstream of the Ferric Chloride weir on the south side of Highway 13 where it would mix until reaching the desiltation pond.

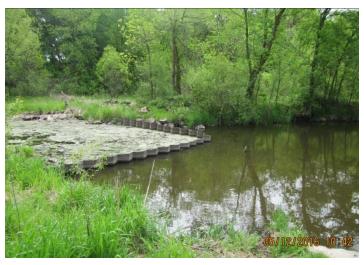
FIGURE 2 BYPASS WEIR

The retrofit project was designed by consultants Bolton and Menk, Inc. and installed by S.M. Hentges & Sons, Inc. The new design allowed for more water to be treated as compared to the old system. With the old system, high flows could resuspend phosphorus-iron flocculants within the basin and flush the flocculent downstream and into Spring Lake. The new system was designed to overtop a bypass weir

(and flow around the desiltation basin) before the flows reached a point of resuspension in the pond. This allows for the maximum amount of phosphorus to be treated without resuspending the material in the desiltation basin. Staff reviewed the project design and confirmed it was operating as designed.

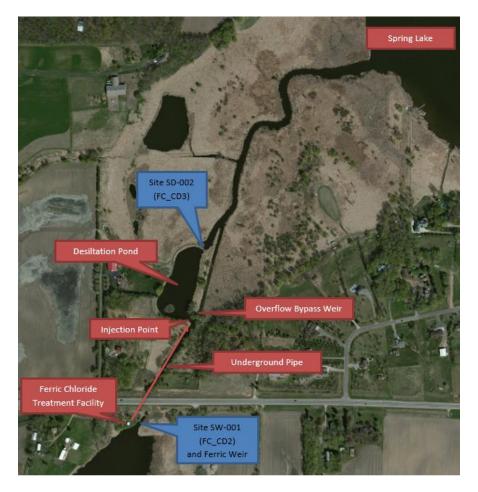
FIGURE 3 AERIAL MAP OF FERRIC CHLORIDE TREATMENT SYSTEM

In July 2013, the treatment facility began operating again after it was retrofitted to meet new MPCA permit requirements. The new design transfers FeCl₃ underground for 900 feet from the treatment building through a

double walled pipe to a culvert north of Highway 13 that flows directly into the desiltation basin. The new design addresses the previous concerns of the MPCA by avoiding direct discharge into a water of the state, and instead, goes directly into a stormwater pond.

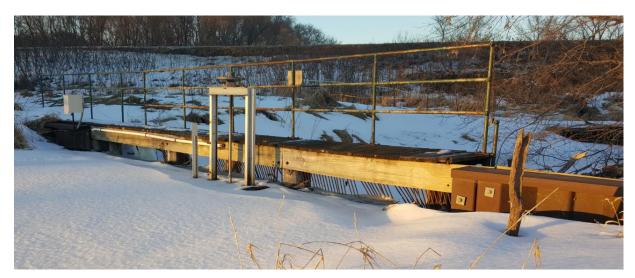
FIGURE 7 FERRIC CHLORIDE WEIR AND FISH BARRIER

Carp have been observed in the wetland adjacent to the Ferric Chloride shed (Highway 13 Wetland) and the water has become noticeably more turbid in the past few years (visually and in the data). The turbid water could be a sign of carp infestation which could have been caused by missing times in the fish barrier on the weir. In 2018, WSB

Consulting estimated 1,452±615 carp are living in the pond, equating to a biomass of 198±61 pounds per acre. Because the current fish barrier is missing tines and inoperable, an engineer at WSB Consulting designed a new concept for the fish barrier. Another option includes an electric barrier immediately downstream of the weir. These options will be further evaluated and if funding is available, construction for a carp barrier may take place in 2019.

The Ferric Chloride weir is also showing signs of age. Repair is anticipated to take place in 2019 to address the cracks, loose boards, and unstable railings.

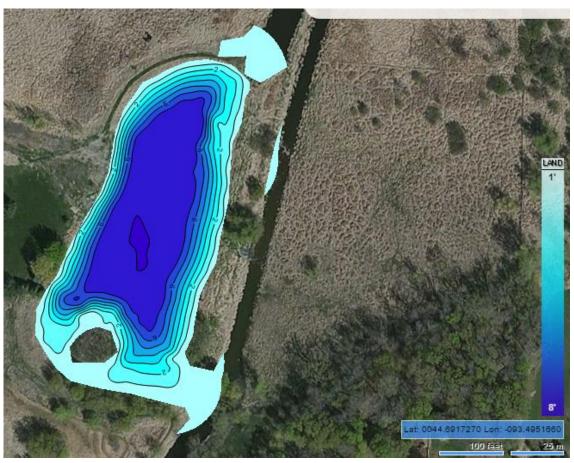
FIGURE 8 BATHYMETRIC MAP CREATED USING BIOBASE SOFTWARE AND PLATYPUS BOAT

The desilt pond needs to be cleaned out (dredged) when the pond starts filling up with sediment. In 2016, a company called Platypus mapped the bathymetry of the pond using a remote-control boat and the District's BioBase software. The pond was found to be about 7-8 feet deep in the middle and many years away from needing to be dredged. Vegetation density and bottom hardness are also simultaneously mapped and available upon request. The bathymetry map is shown below.

The last time the pond was dredged was 2012 and it was dredged down to 902 feet in mean sea level. During the time of mapping in 2016, the pond bottom was about 903.5'. As storage volume is reduced, the detention time for settling and pollutant removal efficiency is reduced. Once the pond bottom nears 908', the pond should be dredged again.

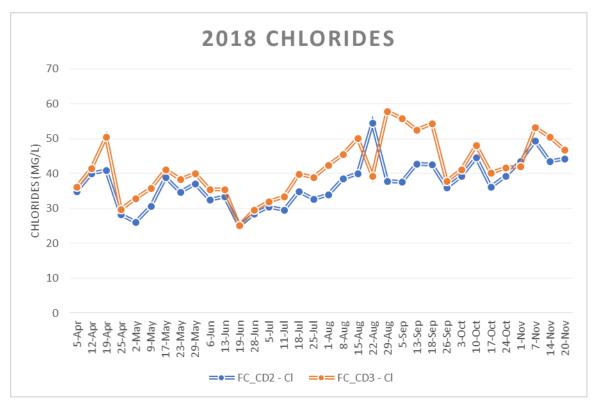
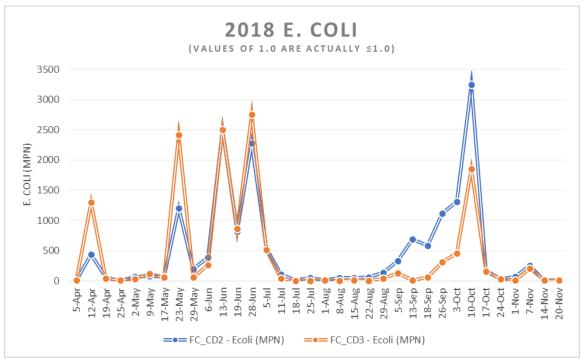
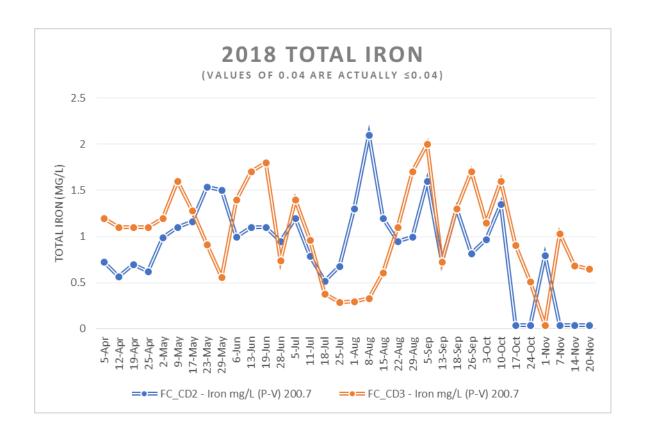
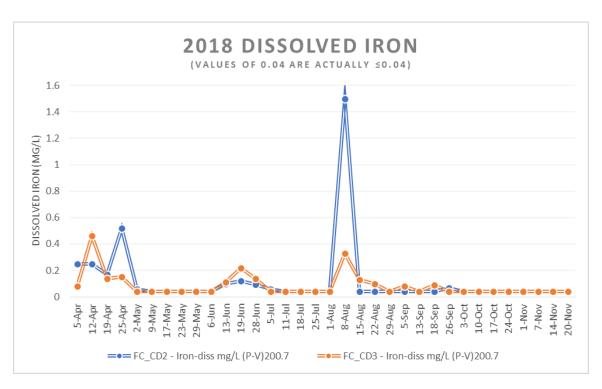
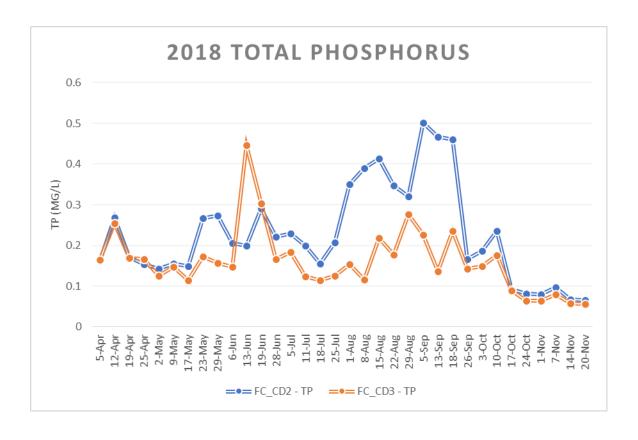
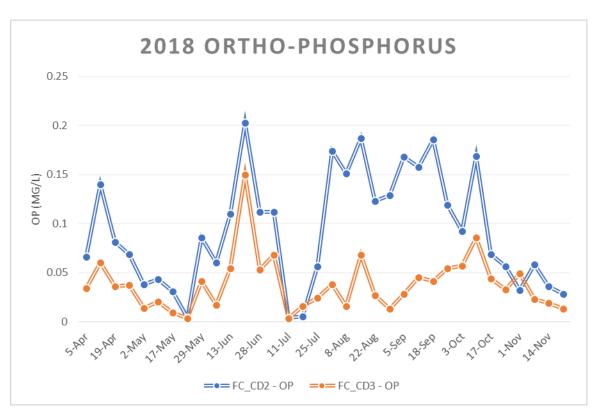
The following graphs display the monthly mean of samples taken in 2018, before treatment at site SW-001 (FC_CD2) and after treatment, at SD-002 (FC_CD3). Treatment began on April 1 and treated continuously until November 20. During that time, samples were taken once per week.
