Ferric Chloride Water Treatment Facility 2020 Annual Report

NPDES/SDS Permit No: MN0067377

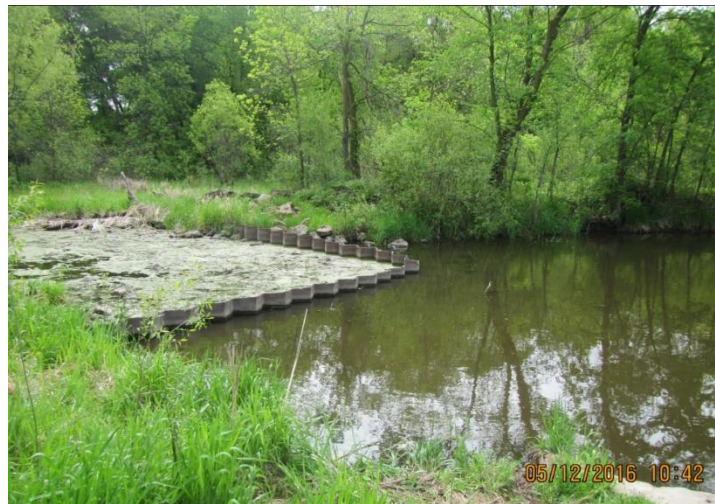
Figure 1. Bypass Weir

The retrofit project was designed by consultants Bolton and Menk, Inc. and installed by S.M. Hentges & Sons, Inc. The new design allowed for more water to be treated as compared to the old system. With the old system, high flows could resuspend phosphorus-iron flocculants within the basin and flush the flocculent downstream and into Spring Lake. The new system was designed to overtop a bypass weir (and flow

around the desiltation basin) before the flows reached a point of resuspension in the pond. This allows for the maximum amount of phosphorus to be treated without resuspending the material in the desiltation basin. Staff reviewed the project design and confirmed it was operating as designed.

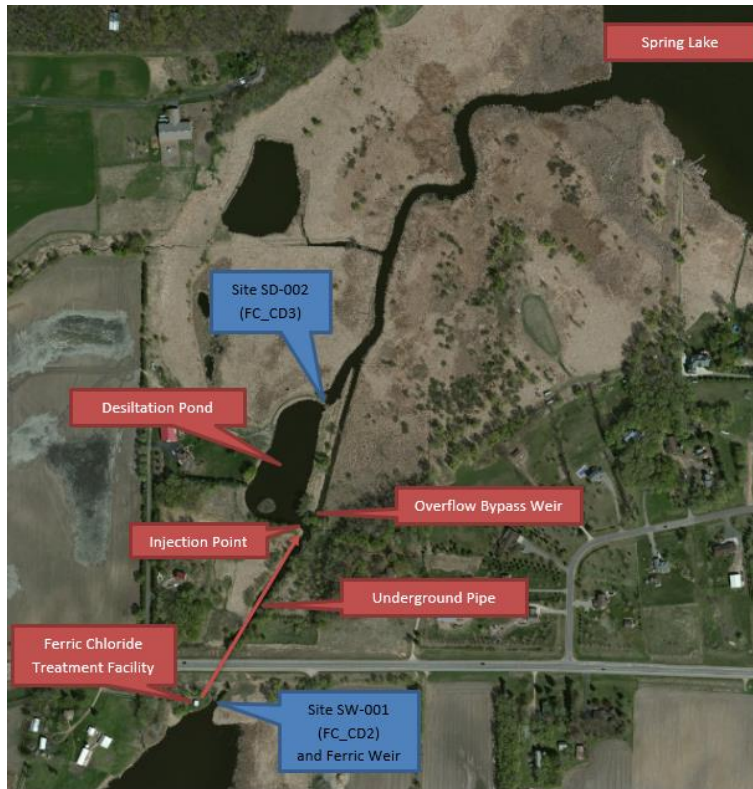
Figure 2. Aerial Map of Ferric Chloride Treatment System

In July 2013, the treatment facility began operating again after it was retrofitted to meet new MPCA permit requirements. The new design transfers FeCl_3 underground for 900 feet from the treatment building through a double walled pipe to a culvert north of Highway 13 that flows directly into the desiltation basin. The new design addresses the previous concerns of the MPCA by avoiding direct discharge into a water of the state, and instead, goes directly into a stormwater pond.

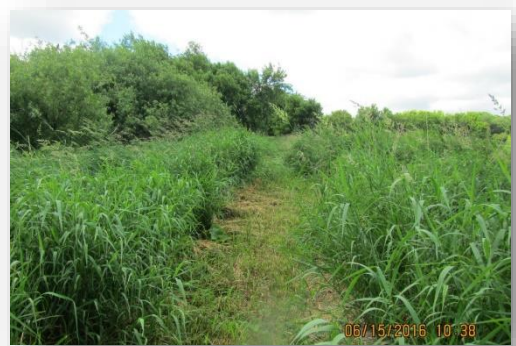
Access is needed to the Desilt pond outlet and injection site. A grass path to the outlet of the Desilt pond was regularly mowed by the homeowner, Gary Stevens. When the water level of the outlet was low enough, he voluntarily drove his lawnmower across the outlet and mowed a path from the outlet of the Desilt pond to the injection site at the berm. When water conditions were too high, staff weed whipped a path to the injection site.

Figure 3. Weed Whipped Path from Desilt Pond Outlet to Injection Site

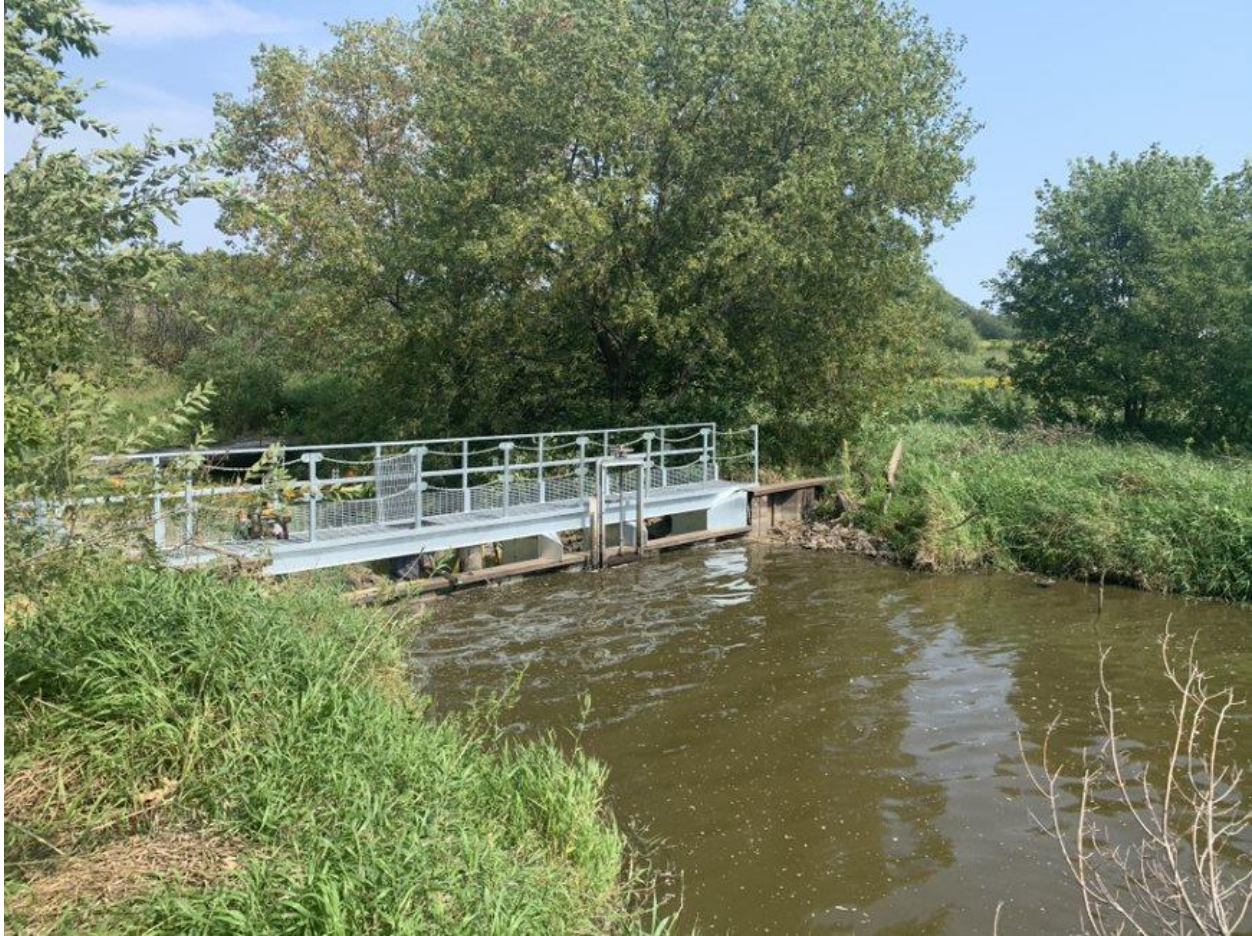
- A temporary fish barrier was installed in April
- Lowered water level in wetland for permanent fish barrier installation
- Permanent fish barrier was installed at the ferric chloride weir in August. The wooden deck over the weir and tines to block fish was replaced with a metal deck which has ability to raise and lower tines to block carp

Figure 4 New walking deck over weir and fish barrier

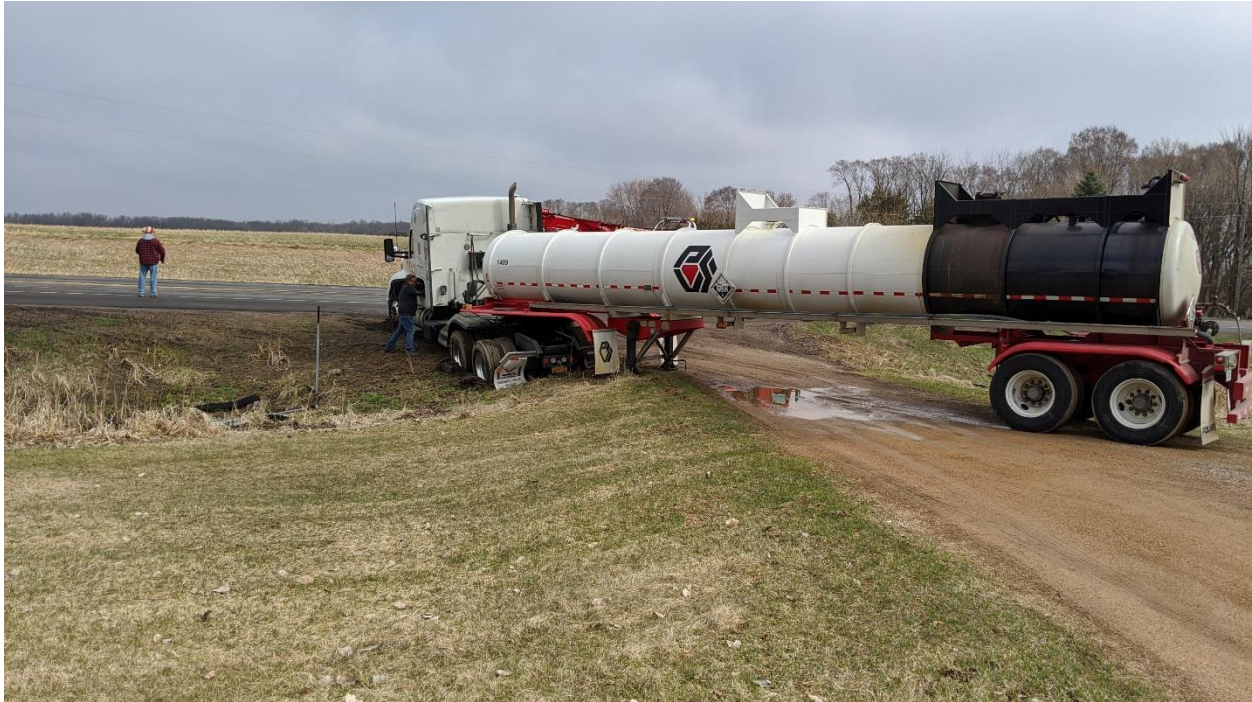
During the April 7 ferric chloride delivery, the tanker truck got stuck in the ditch when trying to deliver. This further enhances the need to modify the driveway to make it safer and easier to deliver ferric chloride. A tow-truck was called to pull the tanker truck out of the ditch and the ditch and grass was destroyed in that area.

Figure 5 Tanker truck got stuck in ditch when trying to deliver

- Repaired damaged grass after ferric delivery truck got stuck

The driveway to the shed continues to be an issue when ferric is delivered. Staff has discussed design options that could reduce the damage done to the Geis's lawn and provide easier access for the delivery driver. Modifications can take place when board of managers approve funds for this project.
