# Aquatic Vegetation Density Mapping 2022 Report

Shauna Capron  
Water Resources Technician  
November 2022

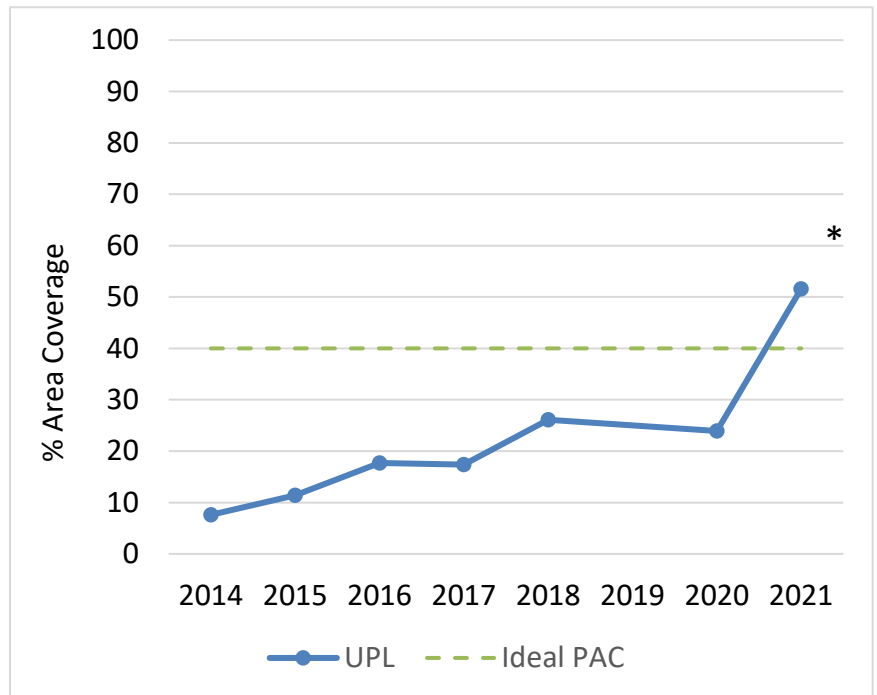
Figure 7. Upper Prior Lake Historic PAC

Upper Prior Lake has historically had trouble meeting water quality standards. Consequently, summer PAC before 2020 averaged only 12%. In recent years (2020 – 2022), water quality standards have begun to drastically improve through intensive carp management efforts and an alum treatment. See more about lake improvement projects on page 7.

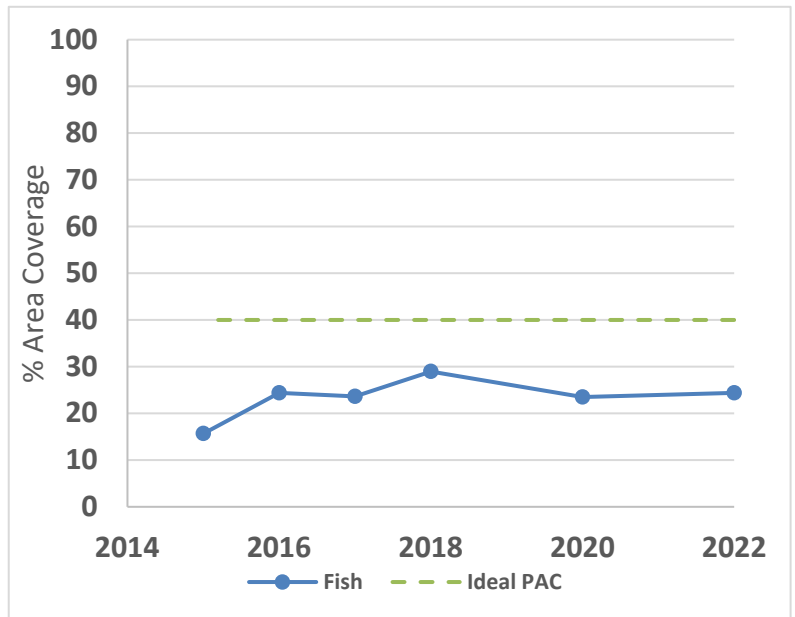
Figure 11. Fish Lake Historic PAC

Water quality results vary in Fish Lake. From the first BioBase trip in 2015 to 2022, the average summer PAC for Fish Lake is 26.1%.

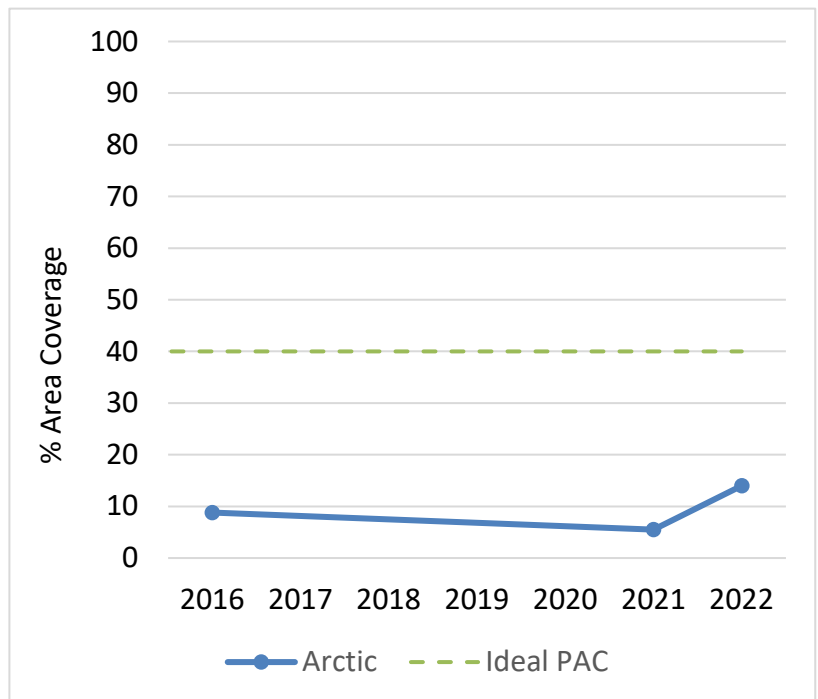
Figure 13. Arctic Lake Historic PAC

Arctic Lake has historically been nearly void of aquatic plants. Poor water quality and clarity may be contributing to the lack of plants. A vegetation study<sup>1</sup> was completed in 2020 by the Shakopee Mdewakanton Sioux Community and found that the seed bank in Arctic Lake sediment is very low in quantity and diversity. From 2016 to 2022, the average summer PAC for Arctic Lake is 9.4%.

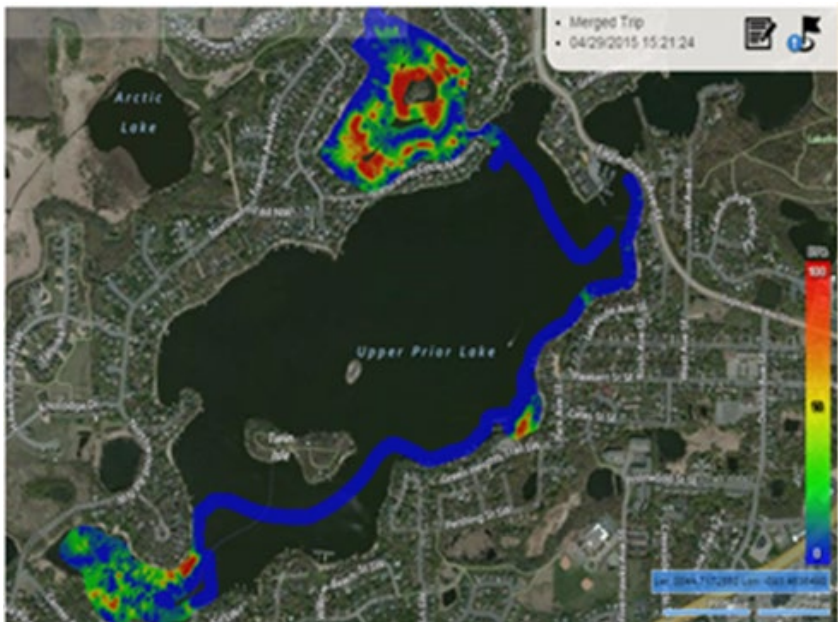
Figure 28. CLP presence before treatment (4/29/15)

For example, in 2015 staff scanned three spots on Upper Prior Lake that were identified to have a high density of plants (the northern-most bay, the southern-most bay, and the small eastern corner). A plant survey helped determine that these spots were dominated by CLP. CLP was then treated in all three areas.

After reviewing before and after maps from the treatment, treatment success appeared to be variable. Treatment was very effective in decreasing CLP density in the northern bay, but the two locations on the south and eastern parts of the lake were less effective – in fact, CLP densities increased! Based off the evidence created by these BioBase maps, the PLSLWD was able to receive a credit from the contractor (\$1,780) to CLP treatment in 2016.
